Ravensworth

CONSERVATION AREA APPRAISAL AND MANAGEMENT PLAN

DRAFT for consultation
November 2014

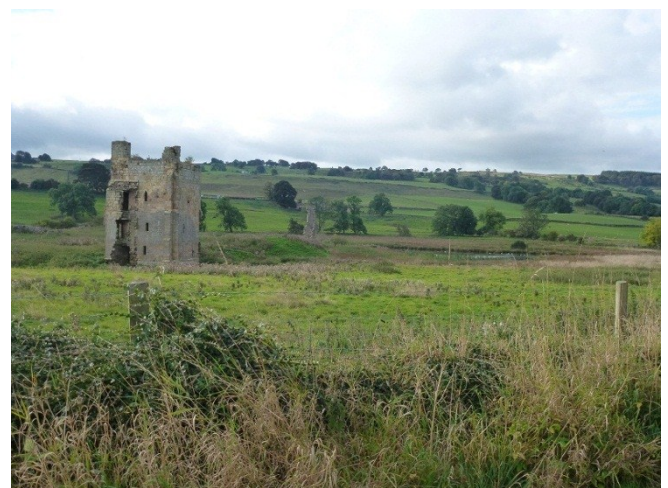
The most dominant built feature within the Ravensworth conservation area is the Castle (photo 5).

Although in a ruined state, significant parts of Ravensworth Castle have survived, and the original plan and layout is preserved. The standing fabric particularly the gatehouse and the belfry tower survive reasonably well and other remains of medieval structures are preserved below ground. Unusually the main defensive feature of the castle was the waterlogged area surrounding the castle which was managed by a system of embankments and channels which still survive as standing earthworks (photo 6). There are also earthworks

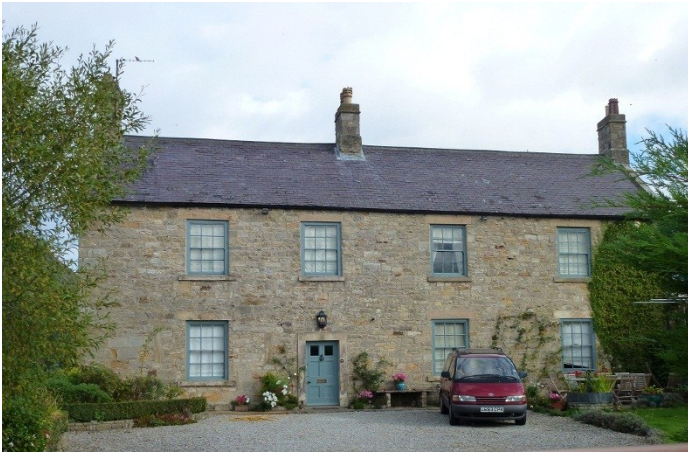
Photo 8

lowered in the mid 19th century and given a Welsh slate roof and sash windows. The gable of the rear wing still retains evidence in the form of a two light chamfered mullioned window and there are part of surrounds of mullioned windows evident on the front and this is a very early form of window. The west gable appears to have been constructed of stone from the castle with two blocked fire windows. A late 18th century garden wall which has an ashlar door surround sweeps up to the main building. To the rear of Tofta House are a range of former functional buildings (photo 9) including a Grade II listed cart shed built of rubble with dressed sandstone three segmental arched quoin openings, and a welsh slate roof.

A number of the older properties have been recognised for their architectural or historic interest and have been Listed Grade II. The earliest of these dating from the late 16th to early 17th century is Tofta House (photo 8), just to the north of the castle. The house is T-shaped in plan, originally of three stories and four bays but

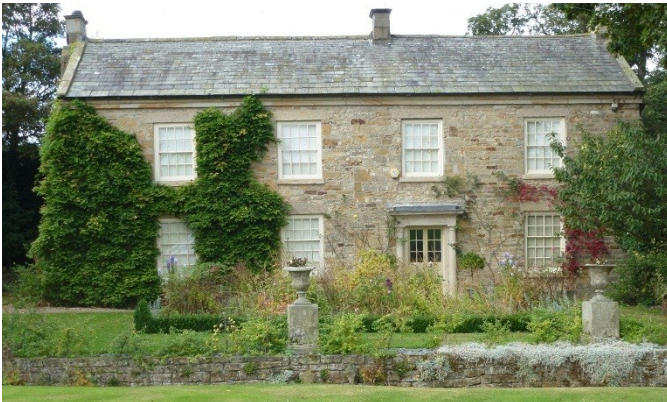
Photo 10

engaged columns supporting a decorative frieze. The main facade has 16-pane sash windows but the older section to the rear retains a chamfered mullioned window. Behind the main buildings is a range of outbuildings including a cowhouse, coach-house and disused livestock enclosure which are all listed Grade II. These are all thought to date from the mid to late 18th century. All are constructed of rubble sandstone with

Of a slightly later date is Park House (photo 10), listed Grade II, built in the mid to late 17th and late 18th to early 19th century. It has an irregular U-shaped plan with the early house now forming the left rear wing, possibly with early extension forming 2 bays left of the main façade and with later 19th century service buildings to the rear right. The front façade is two storey with 4 bays and unusually for the village it has a Westmorland slate roof. The door-case has fluted Tuscan

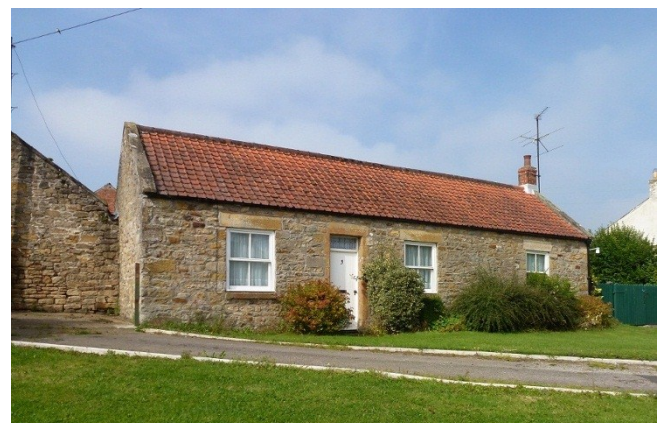
Photo 11

Mill Farmhouse Cottage (photo 11) is dated 1699 and of a far more humble design than the two earlier houses. It is single storey of rubble sandstone with quoins and a modern clay interlocking tile roof. The property has 3 bays and 4-pane sash windows with projecting cills and deep herringbone tooling. This window surround detail with the tooling feature is common on many of the older properties.

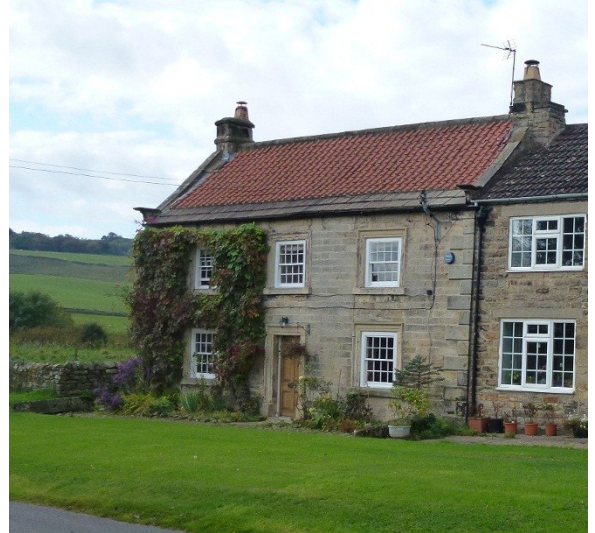
39 The Green (photo 12) dates from around 1700 with later alterations. The main façade of this house is ashlar, which is rare in the village, with coursed rubble to the rear and side. The roof is of modern pantiles with stone slate eaves course and shaped kneelers, ashlar copings and end chimney stacks. The house is two storey with three bays. It has rusticated quoins and architraves to openings with a six panel door and 16-pane sash windows.

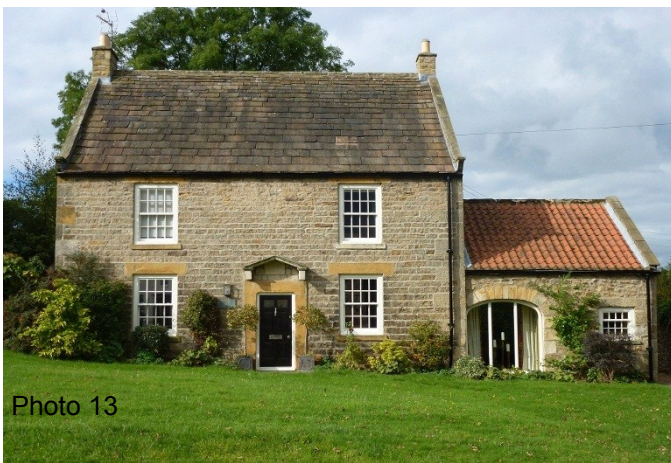
Photo 13

15 The Green (photo 13) dates from 1786 with an early-mid 19th century outbuilding. The house is of coursed dressed sandstone with quoins and has a stone slate and pantile roof with shaped kneelers. The house is two storeys and two bays with a central door with ashlar surround, incorporating a medieval inscription protected by a pediment.

The windows are 16-pane sashes with projecting cills and deep lintels incorporating the inscription 'IE 1786'. A single storey building to the right incorporates an arched opening of dressed stone, presumably for a cart.

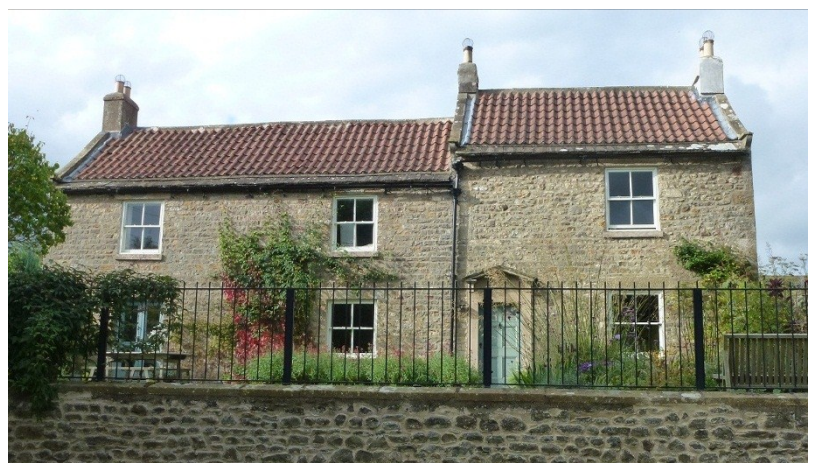
Photo 14

In the late 18th century to early 19th century Mill Farmhouse (photo 14) was built and has had 20th century alterations. It is constructed of coursed watershot, rubble which is rare for the village,

with a modern pantile roof that has a slate course at eaves with shaped kneelers and ashlar copings and brick end stacks. It is two storey and of two parts, the older part being to the left with two bays, The later range to the right is slightly taller and has one bay with a door to the left in an ashlar surround with pediment. The windows are 4-pane modern sashes with cills and deep lintels. In front of the house is a cobbled

garden wall with ashlar copings swept up at the sides to a lower front wall and a modern iron railing.

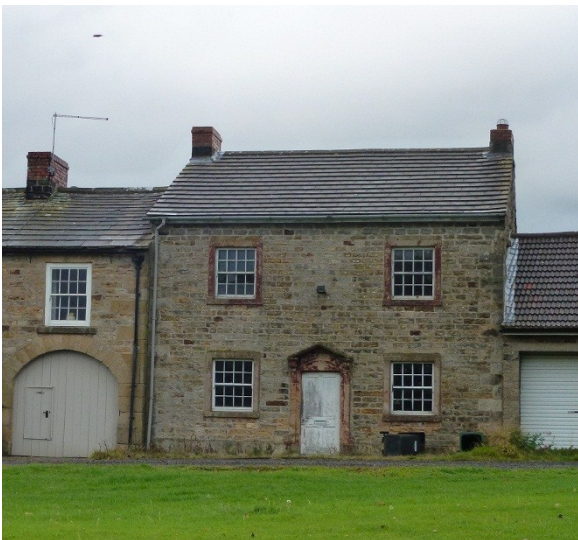
Photo 16

30 The Green (photo 16) is of a similar date, again of coursed rubble sandstone with quoins. Unfortunately the building has a concrete tile roof but other aspects of the design follow the typical in Ravensworth, two storey two bays with a central door with ashlar surround and a pediment. The windows are 16-pane sashes in ashlar surrounds.

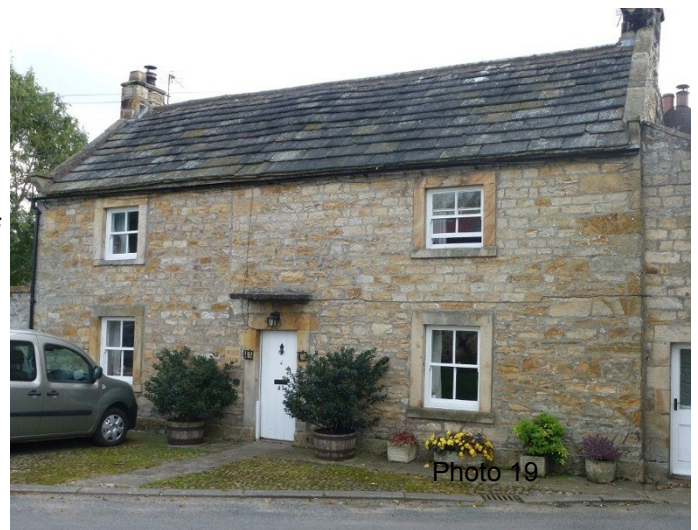
Photo 18

The remaining listed properties date from around 1900 and the majority form a group to the north side of the village green : no 20 with attached building to left; no 24; no 26 (photo 18); and no 28. No 2 (Sunset Cottage) is also from this date, but located a little further north away from the main green. No 20 is two storey built of rubble sandstone with a pantile roof that has a stone eaves course, shaped kneelers,

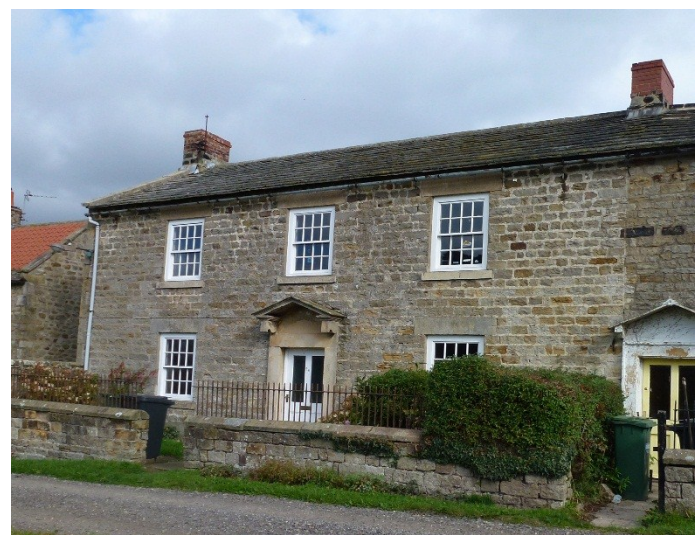
Photo 19

No 2, Sunset Cottage (photo 19) completes the older houses of the village. It is built of coursed rubble sandstone with one of the few Welsh slate roofs in the village. It has two storeys and two bays with a central door in an ashlar surround. Sash windows have 16-panes with projecting cills and deep lintels.

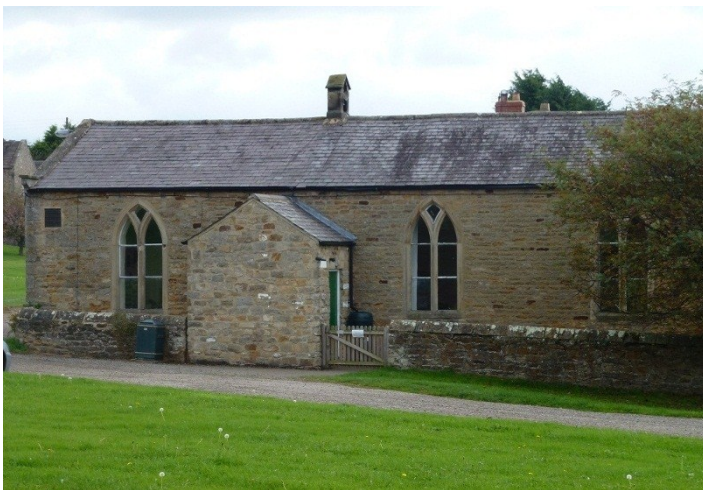
Photo 20

The remaining building of architectural and historic interest in the village is the Village Hall (photo 20). It was built in 1841 as the National School and constructed of coursed rubble with quoins. The roof is Welsh slate with shaped kneelers and ashlar copings. It is the one of

two buildings in the village with pointed arch windows of two lights with Y tracery. It has an ashlar bellcote and an end chimney stack.

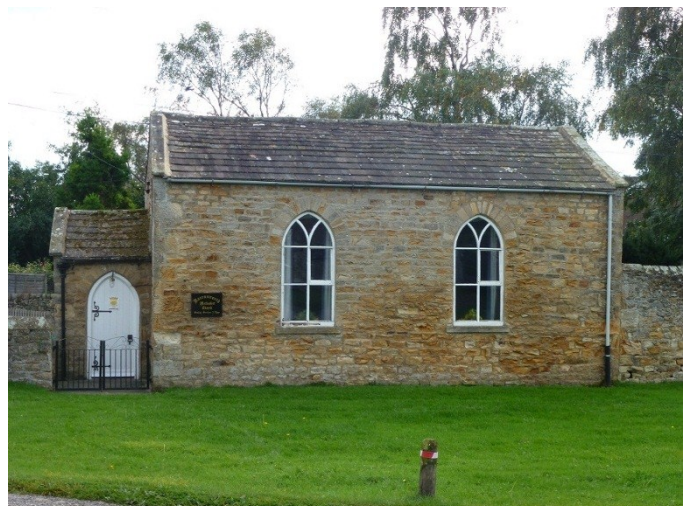
Photo 21

The other building with pointed arched windows is the Wesleyan Chapel (photo 21) which is next to the Village Hall and dates from 1850.

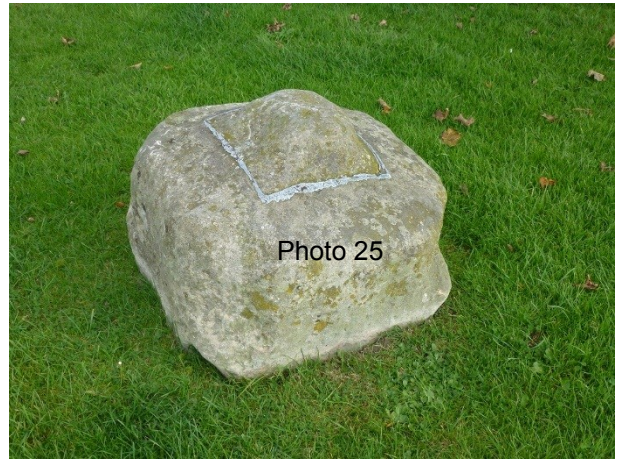
Photo 22

The cross base (photo 22) – possibly from the sixteenth century now badly worn, square in plan with the upper corners chamfered and broached stopped. A bump on the upper surface indicated the joint for the next section of the shaft.

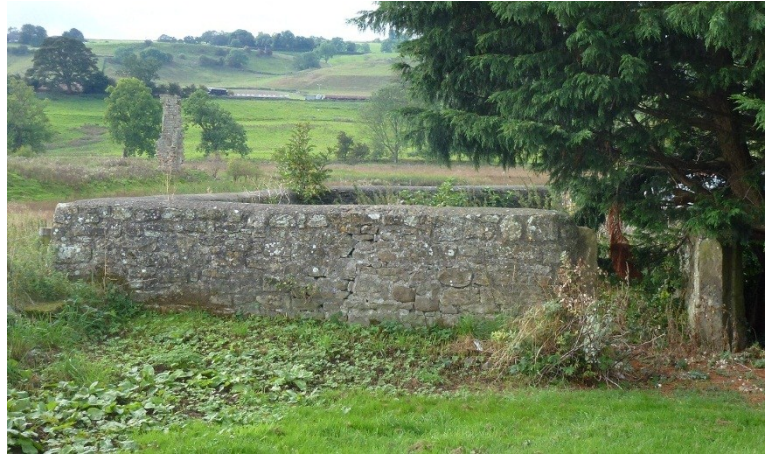
Photo 23

The village pound (photo 23) – thought to date from the 18th century in the form of an irregular oval enclosure of rubble stone with a monolithic gate post to the north-east.

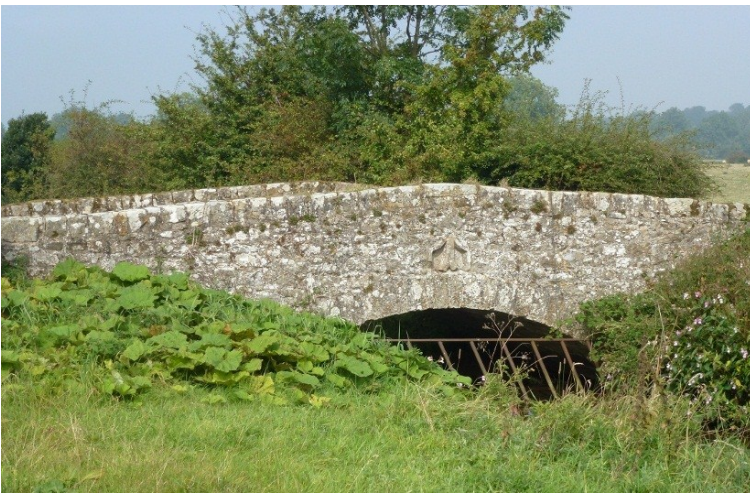
The footbridge over Holme Beck 120 meters to north-west of Mill Farmhouse (photo 24) – from the early nineteenth century a single segmental arch of dressed voussoirs and soffit with herringbone tooling. The bridge includes a Gothic window head and other carved stone though to be from Ravensworth Castle.

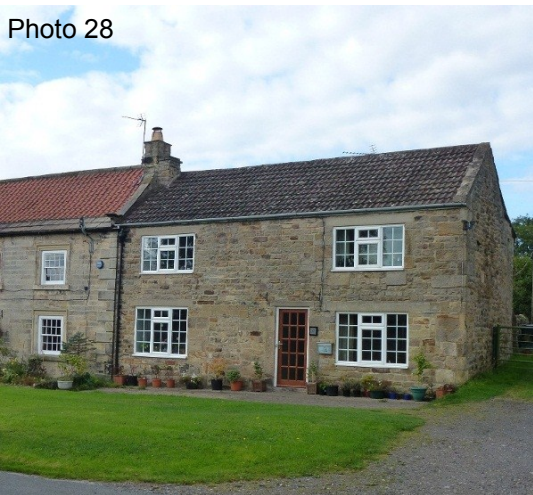
Photo 28

with projecting eaves and deep lintels. Those windows with a horizontal emphasis would originally have had horizontally sliding Yorkshire sashes. These windows are often found to the rear of properties or on outbuildings etc. and can be seen on the buildings attached to 20 The Green. Chimney stacks are at the ends (photo 26) of roofs. There is a dominance of solid over void in walls that is shown on 22 The Green (photo 27). There are some properties where new windows and enlarged window openings have been provided over more recent years, such as at 37 The

Green (photo 28). Porches are not a traditional feature, though they do occur on some of the later 19th and 20th century properties. Traditionally dormers and rooflights are not found on elevations fronting on to the village green. The lie of the land means that there is a constant stepping up/down in the levels of the properties which is particular evident in the variation of the roof levels (photo 29). Most of the properties front directly onto the village green though some have a small forecourt area behind a small enclosure of a stone wall and/or railings (photos 29, 30 and 31).

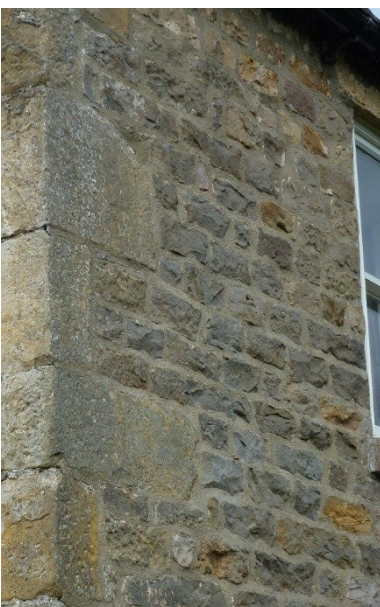
Photo 39

in the village are constructed of local stone. The majority of cottages and houses use random or coursed rubble (photo 38) construction for the walling. There are two main exceptions to this and that is the use of watershot rubble at Millhouse Farmhouse (photo 39) and ashlar at 39 The Green (photo 40). Ashlar is also use for the surrounds of openings often with a herringbone tooling pattern as can be seen at 15 The Green (photo 41). Most of the window openings have deep stone lintels which often has the herringbone tooling and projecting stone cill. An

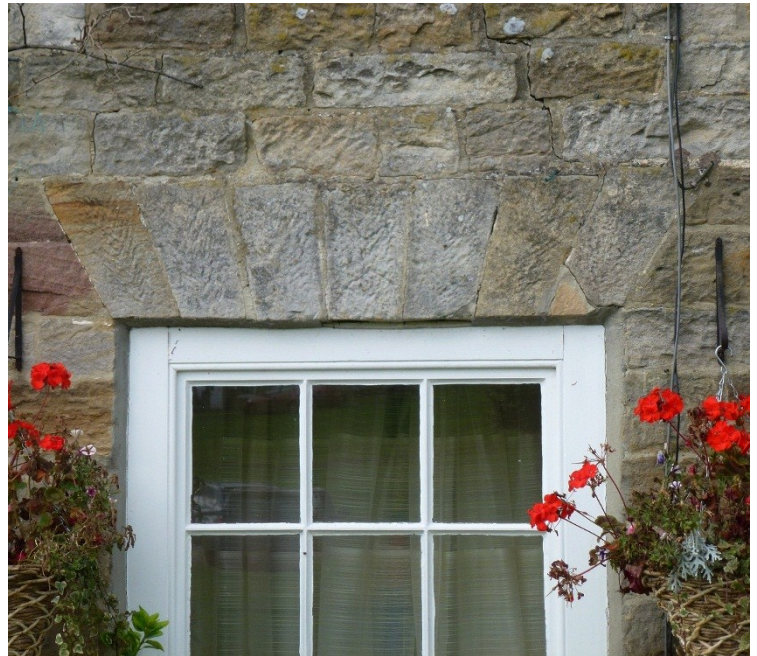
Photo 42

exception to this is the voussour stone details on 31 The Green (photo 42) and the moulded stone surrounds of 39 The Green (photo 43).

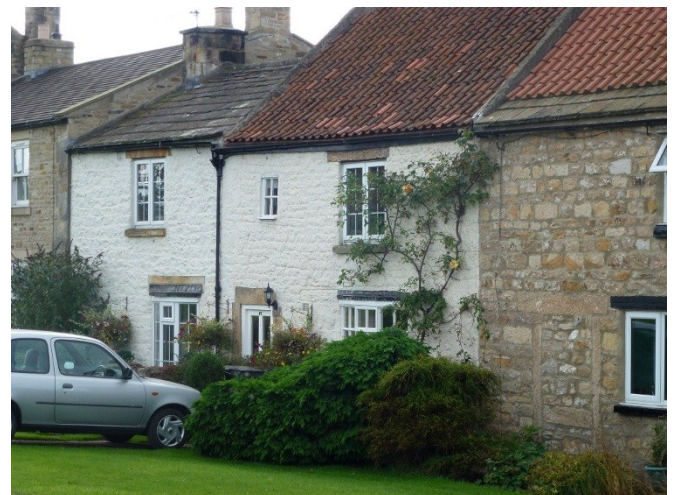
Photo 44

Lime wash was a traditional way to weatherproof the poorer quality of stone and would have appeared as a colour finish to a property and one of the properties on the green does have a colour finish to the stonework (photo 44).

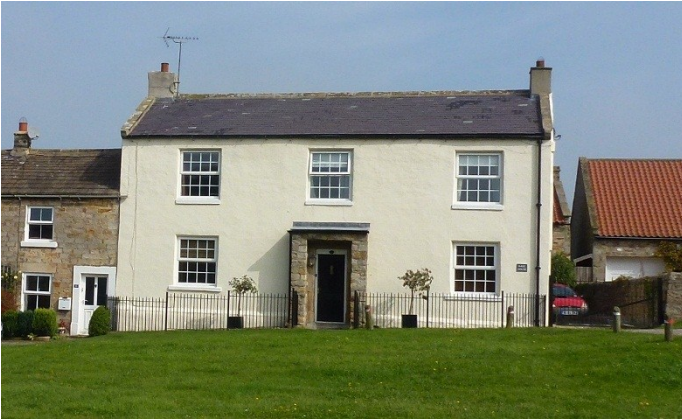
Photo 45

Render comes in a number of forms, traditional rough cast render, modern cement render and pebble dash. There are very few rendered properties in Ravensworth Conservation Area. No 18 The Green is a prominent white painted cement rendered property (photo 45) and certainly

stands out as being different to the character of the village, as do the two semi-detached pebble dashed properties to the north east of the Village Green (photo 46).

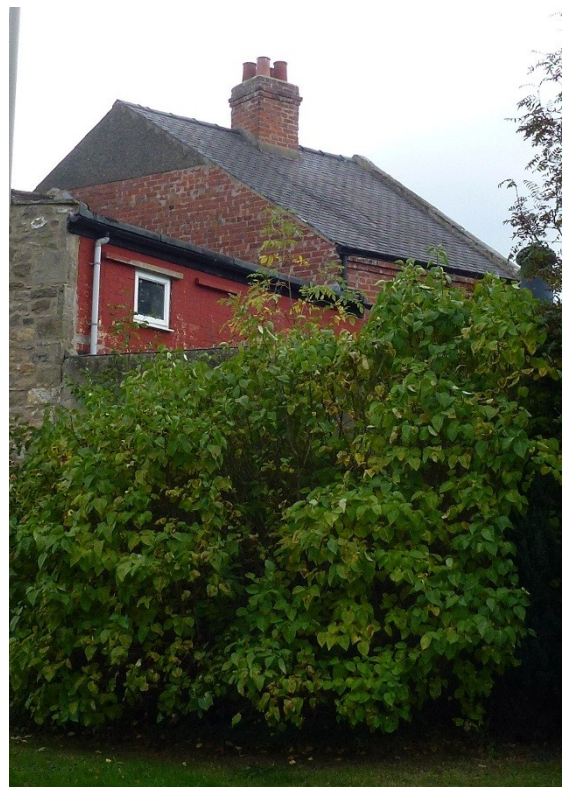
Photo 48

Brick is rare in Ravensworth and only appears notably in the chimneys and rear elevations, such as the back of the Bay Horse Inn (photo 47). It has also been used to construct a very few small ancillary buildings/boundary walls such as The Cedars (photo 48) and chimneys but these are less prominent in the Conservation Area. Brick has not been used for any significant external work on buildings in the village and, in a similar manner to render, brick should be resisted in its future use in the village in order to maintain the dominant use of natural stone which gives Ravensworth so much of its individual character.

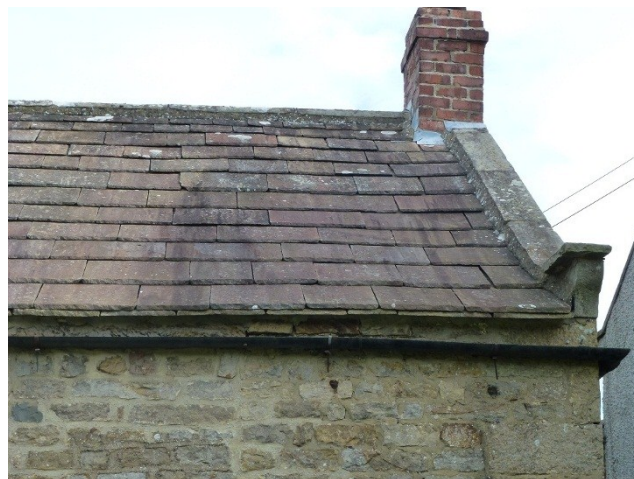
This has been historically used for domestic roofing in the area (photo 49). The stone slates will have been locally sourced. The sandstone slates are thick in comparison to other roofing materials and are laid in diminishing courses, narrowing from large slates at the eaves to small slates at the ridge, often finished with a dressed stone ridge piece. This produces a distinctive character to the roof very

different from other natural slates as the covering is notably thicker and the roof has a textured finish arising from the thick slate edges. Although when first quarried the sandstone slates are a pale grey/buff colour they weather in time to a deeper grey/brown colour slightly darker than walling stone. Good examples of stone slate roofs can be found on many of the listed buildings namely 15 The Green (photo 50), 24 The Green, 26 The Green and 28 The Green. The stone slates are often combined with pantiles as an eaves course as referred to below.

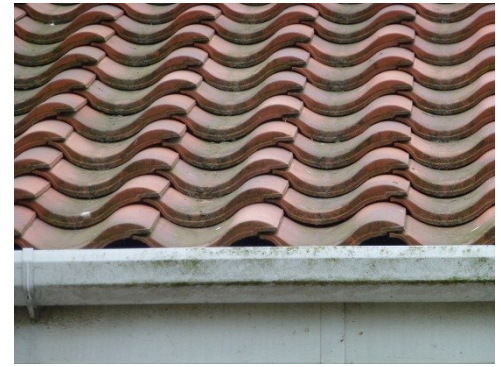
Some of the original roofs of the village have been replaced with interlocking pantiles (photo 52) and although these do not quite have the character of the original, they assimilate reasonably well into the overall street scene.

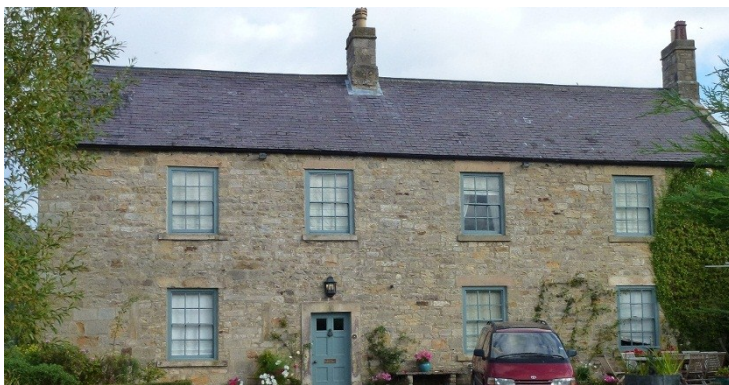
Photo 53

imported to the area. The use of slate has continued alongside pantiles in both re-roofing buildings such as Tofta House (photo 53) and Sunset Cottage but also as a traditional alternative to pantiles and these are best seen at The Village Hall (photo 54) and 18 The Green.

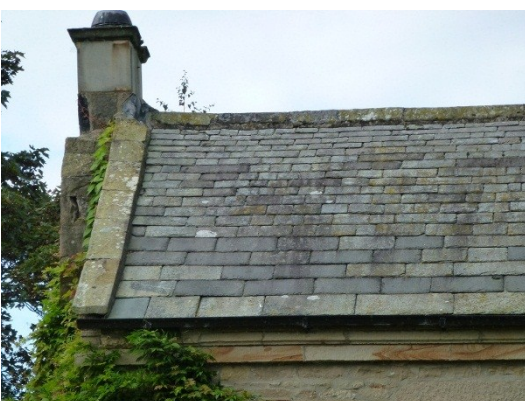
Photo 55

Westmorland slates are a grey/green colour and are rare in the area generally. Park House (photo 55) being the only house in the Conservation Area to be roofed with these slates. They are laid to diminishing courses in a

similar manner to the local stone slates, but they are not nearly as

thick and more akin to the Welsh slates. This is an unusual material to find in a location that is so well provided with good quality stone roofing slate and may be an indication of the high status that this prominent village house has always

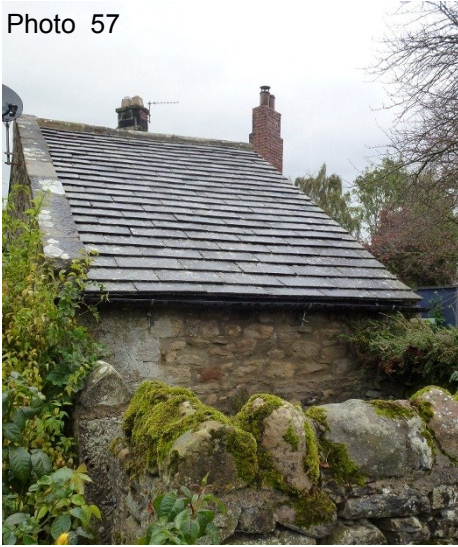
Photo 57

tiles. Concrete tiles have been used extensively on village properties through the later part of the 20th century to replace older traditional stone slate roof coverings and come in a number of forms both profiled (photo 56) and flat (photo 57). Although not ideal for traditional buildings due to the characteristics of the material itself and the regular mechanical appearance of the finished roof, which differs

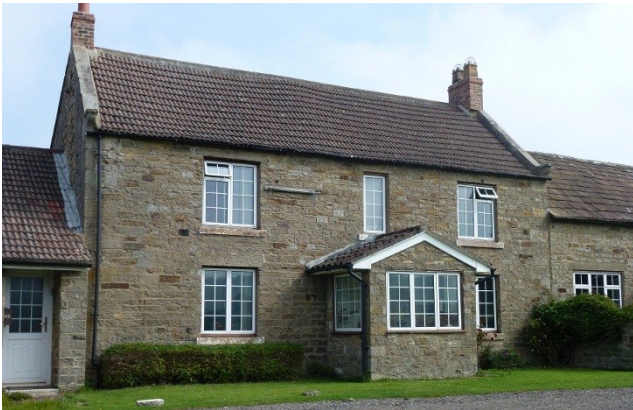
Photo 58

from the traditional slates or pantiles, the flat tiles have usually mellowed with weathering to blend into the street scene (photo 58). Unfortunately the same cannot be said for the profiled concrete tiles (photo 59). Ideally these will be replaced with

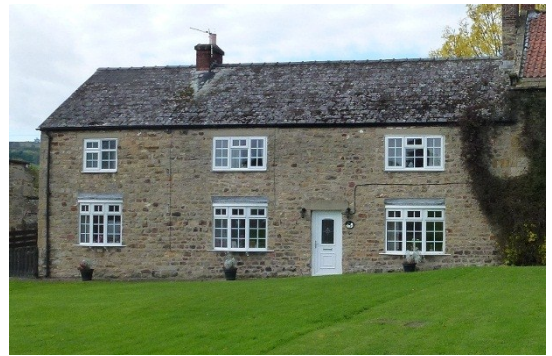
Photo 59

more traditional alternatives as they become life expired.

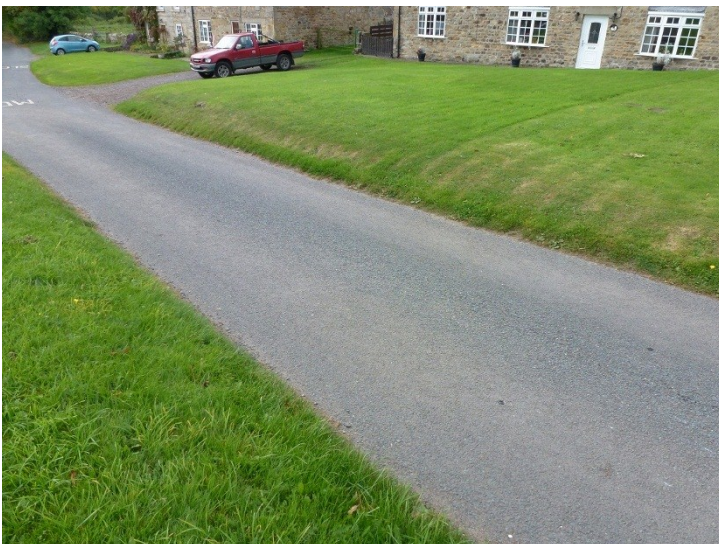
Photo 60

The village is dominated by the expanses of Village Green which in a lot of areas remains unbound by kerbs (photo 60). In some locations it appears to have been necessary to formalise the demarcation between the roads and the green/verges and a number of means have been used to achieve this, including

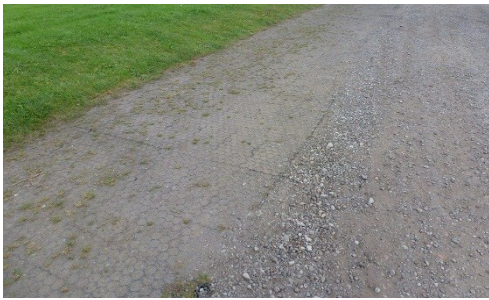
Photo 63

the standard highways concrete kerbs (photo 61), granite setts (photo 62) and 'grasscrete' (photo 63) .

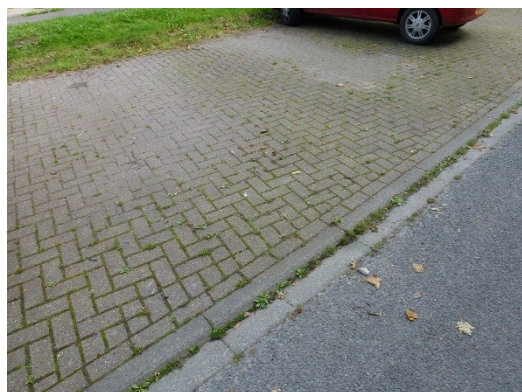
Photo 68

roads to the properties on the village green remain un-metalled and are generally crushed gravel (photo 66). Private drives feature a range of surfacing from informal beaten earth paths and rough rubble, through a range of gravels and crushed stone, to concrete, tarmac (photo 67) and modern block paving (Photo 68). This last form of surfacing which is seen

substantially on the modern developments of Mill Close and Mill Court/rear of Tofta House (photo 69) provides a very mechanical finish very much at odds with other aspects of the village.

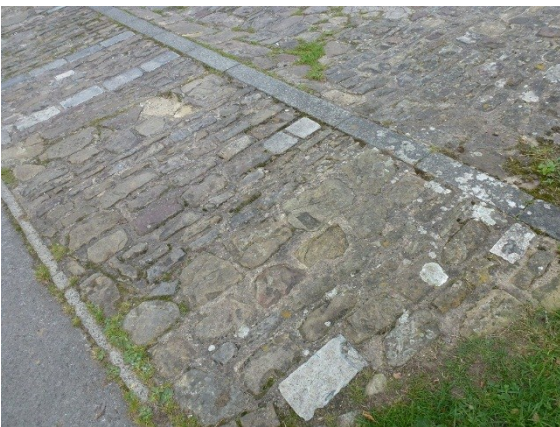
Photo 73

Stone flags also appear to the frontages of some properties such as 7 The Green (photo 73), where they have unfortunately been badly damaged, and at the rear of the Bay Horse Inn where there is a good example of stone setts (photo 74).

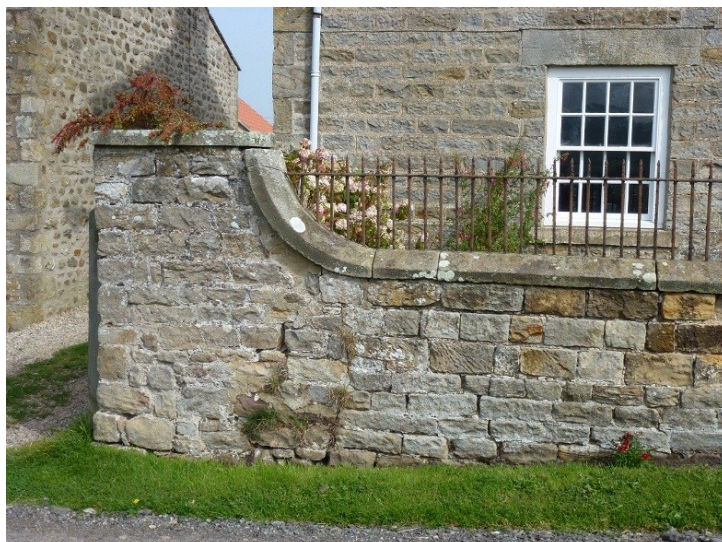
Photo 75

There are two types of boundary treatment used substantially in Ravensworth. Stone walling, sometimes accompanied with railings and hedging, and found throughout the built part of the Conservation Area is either coursed rubble stone to the front of more modest village properties or the formal dressed stone walls in front of some of the larger houses such as Tofta Farmhouse where ashlar stone is used for the gate piers. The variety in form of copings in the village is worth noting with pyramidal dressed stone (photo 75)

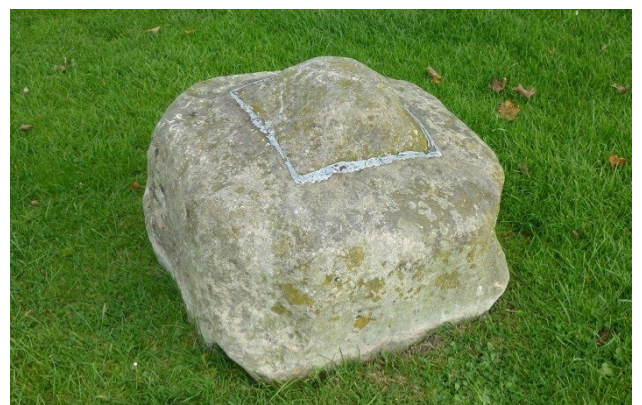
Photo 86

There is a limited amount of street furniture in Ravensworth but the range that exists includes several important items, which make a valuable contribution to the character of the Conservation Area. The most prominent item on the Village Green is the cross base (photo 86). Although the telephone kiosk (photo 87) positioned to the west of the Green is of a standard national design, it has an important

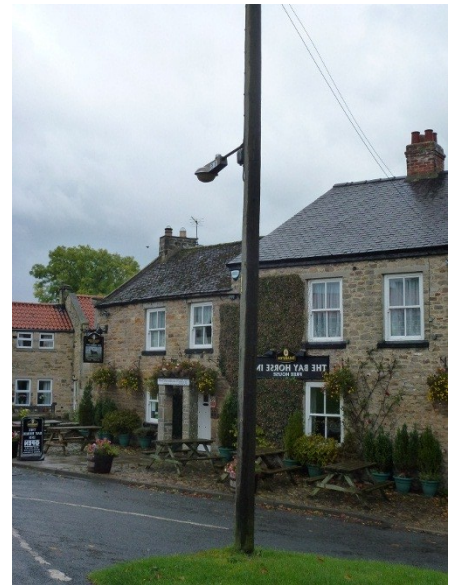
Photo 90

Street lighting is provided throughout the village on a series of modern brackets mounted on existing poles, these are quite sparse and their design is poor (photo 90) in a historic context.

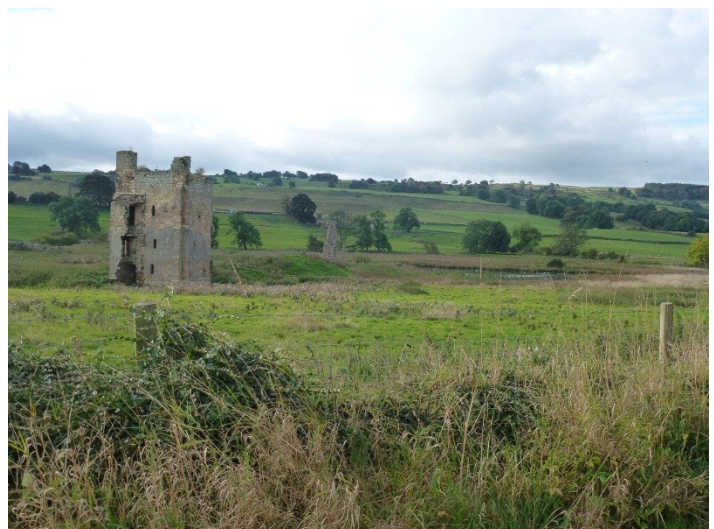
Photo 98

To the south east of the village within the Conservation Area are the low-lying ruins of Ravenworth Castle (photo 98). As described earlier these consist of an open scrub/pasture and wetland area with some standing ruins. This area is of high archaeological value and has been recognised as being both a Schedule Ancient Monument and a Listed Building. Though the castle's link with the village is beyond question, its physical impact on the village is limited to the robbed building materials from the ruins that can now be seen

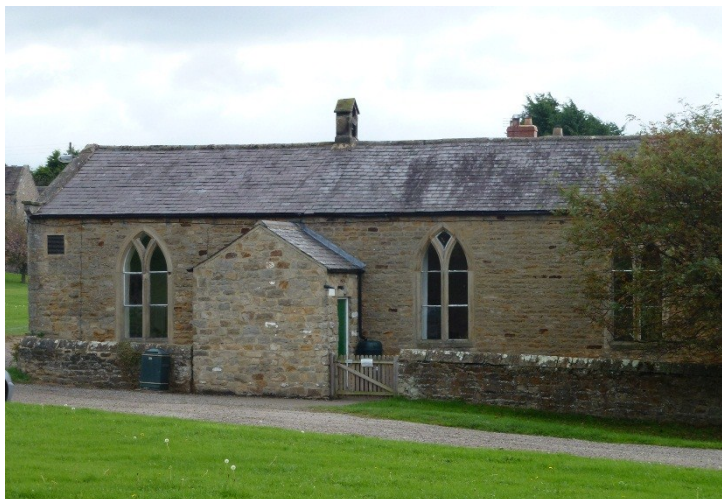
Photo 103

reinforcing the feeling of enclosure around the Green. The general unity in the colours of materials gives the impression of a homogeneous built form but on closer inspection there are unique differences between buildings such as the pointed arched windows of the Village Hall (photo 103) and Chapel (photo 104),

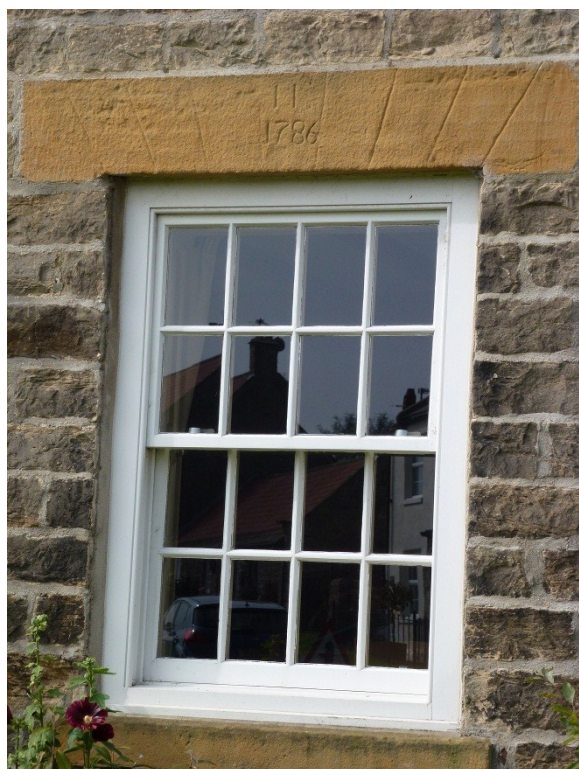
Photo 105

the deep flat lintels (photo 105) and the use of voussoirs (photo 106).

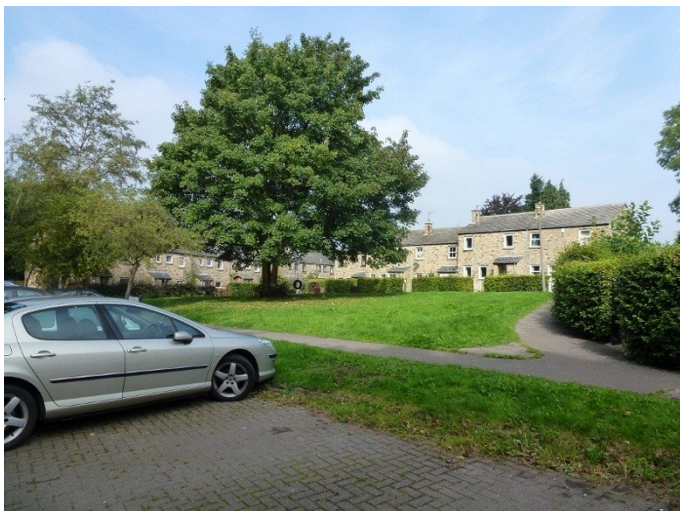
Photo 112

Mill Close (photo 112) was built in the 1970's as substantially a series of terraced properties around three sides of a green square set to the east. One other row of terraces and a detached property were built to the west of these which reinforces the enclosure of the Village Green (photo 113). The use of a pallet of local building materials (stone and pantile) on the prominent properties helps to assimilate these

buildings into the grain of the village, but on closer inspection the type of stonework, boundary treatment, change in proportions of solid over void etc. do mark the properties as essentially modern.

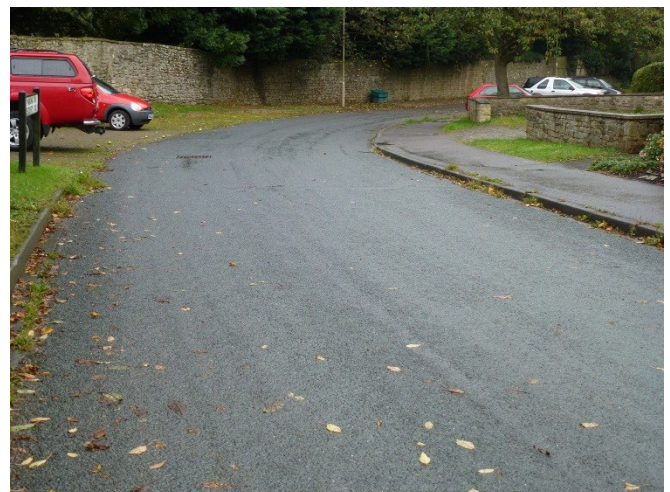
Photo 111

These two late twentieth century developments are very obviously modern and this is particularly evident in the standard highways design (photo 111), but overall they are not intrusive to the character of the area, due primarily to the form of the new buildings and the use of traditional materials similar to the local vernacular.
